# **INDOOR AIR QUALITY ASSESSMENT**

**Greenfield Public Library  
402 Main Street  
Greenfield, Massachusetts**

Prepared by:  
Massachusetts Department of Public Health  
Bureau of Environmental Health Assessment  
February, 2002

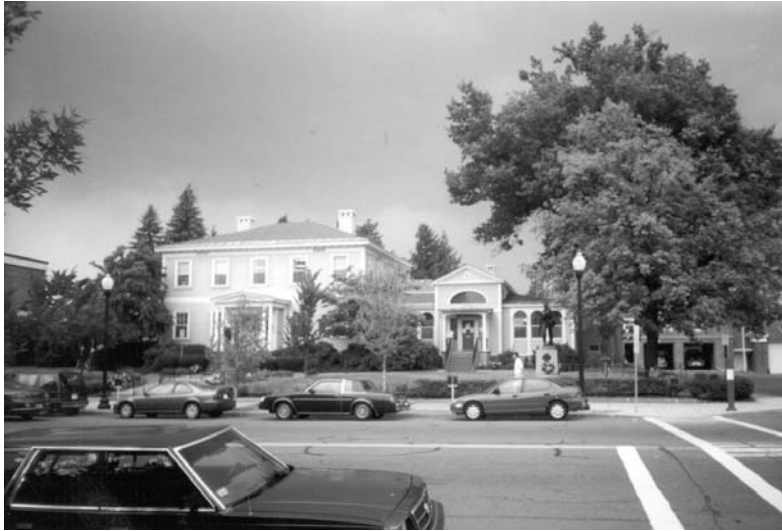
**Picture 1**

The library contains two wings in a split-level configuration. The original wing was a free standing, two-story, wood frame mansion constructed in 1797 (see Picture 1). A two-story brick wing was added to the rear of the building in the 1950s. The library occupies the first floor of the 1797 wing and the second floor of the 1950s wing. The second floor of the 1797 wing is used for administrative offices. The ground floor of the 1950s wing contains a conference room, an office and restrooms. The basement of the 1797 wing is used for storage of books and contains a mechanical room and the custodial office. An elevator shaft services each floor of the 1797 wing. Windows are sash windows that are not openable. The library exhaust ventilation was renovated in 1998 (MJA & KL, 1998). Exhaust vents were removed and new motors were added to the basement and first floor.

**Wood Frame Mansion Constructed In 1797**

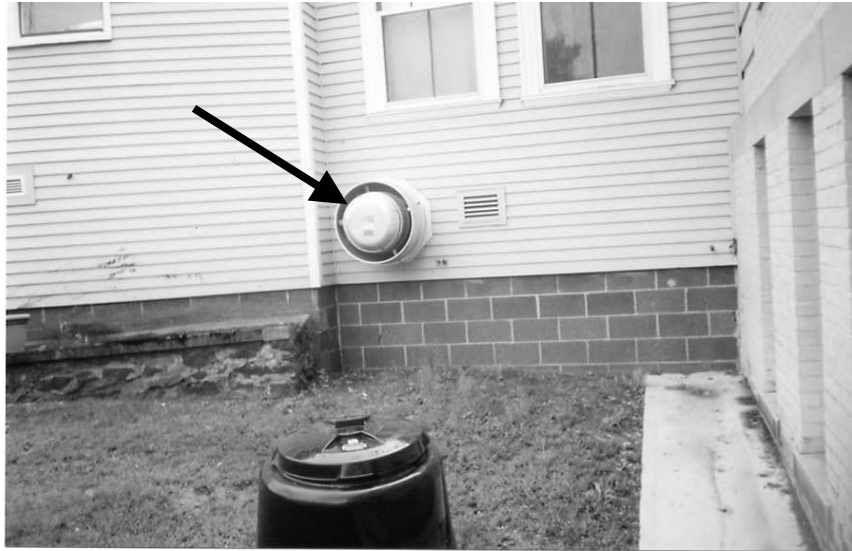
**Picture 2**

Exhaust ventilation is provided by ceiling-mounted exhaust vents in the first floor library areas. The basement conference room has a wall-mounted exhaust vent, which is connected to a large fan installed on the rear exterior wall (see Picture 2). In all areas examined, exhaust vents were deactivated. Without a functional exhaust system,

**Exhaust Fan for Basement Meeting Room**

8. Operate the basement conference room exhaust ventilation fan when the univent is operating to remove water vapor.
9. Survey all univent functions to ascertain if an adequate air supply exists for each room and make univent repairs as needed. Check fresh air intakes for repair and increase the percentage of fresh air intake if necessary. Consider consulting a heating, ventilation and air conditioning (HVAC) engineer concerning the calibration of univent fresh air control dampers building-wide.

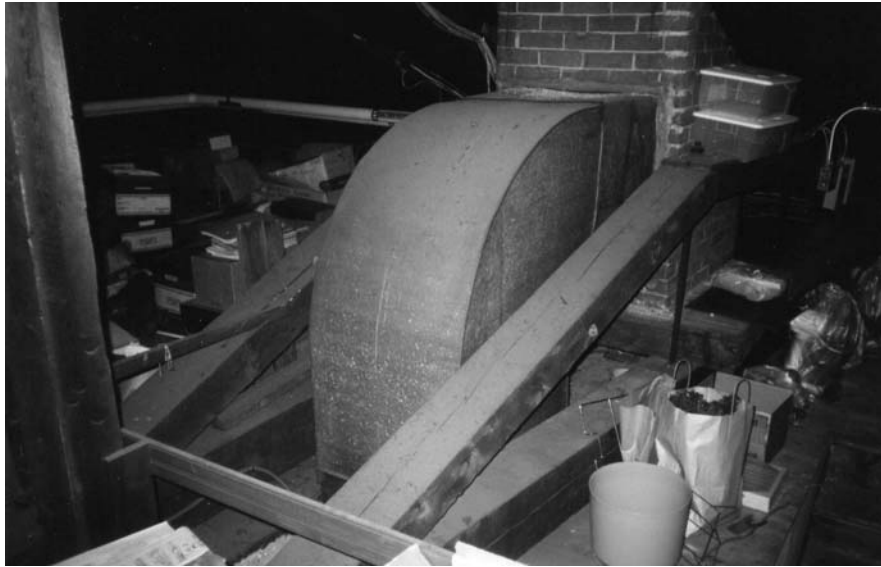
**Picture 3**

The administrative offices on the second floor do not have mechanical exhaust ventilation. The roof of the 1797 wing has two chimney-like structures, which appear to be exhaust ventilation airshafts. A large grill in the staff office appears to be connected to the western brick ventilation shaft by ductwork (see Picture 3) in the attic. A second large grill located at the top of the stairwell from the first floor may also be connected to the eastern brick ventilation shaft. The sound of vehicle traffic was noted emanating from this grill, indicating the airshaft is likely open to the outdoors. These vents are not mechanical, but use rising, heated air to draw environmental pollutants from the building. While this system can work well during the heating season to provide exhaust ventilation, the system does not work during the air-conditioning season. These vents may also serve as a moisture source during summer weather. Additionally, a number of areas in the basement do not have mechanical fresh air supply systems (see Tables).

**Ductwork in Attic Connected to the Western Brick Ventilation Shaft**

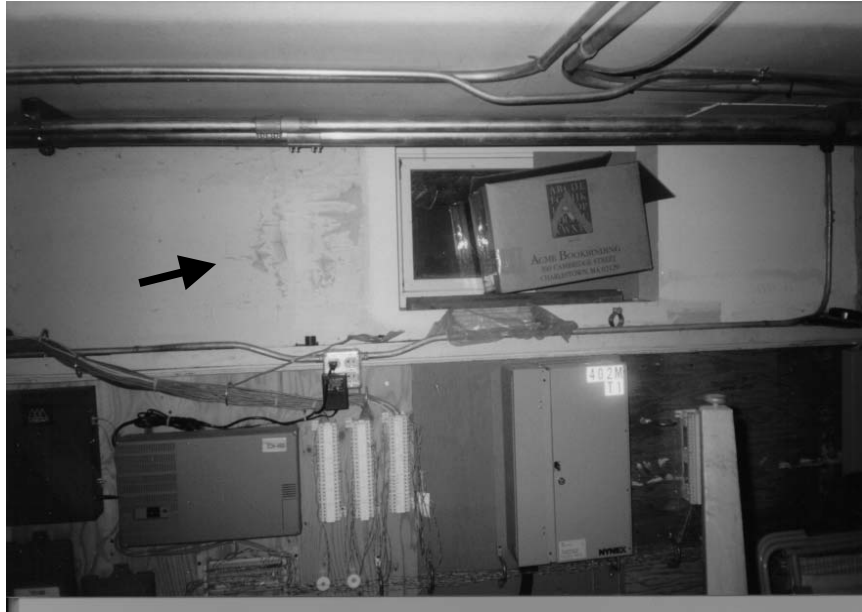
**Picture 4**

A second possible means for introducing moisture into the basement area is chronic moistening of the rear exterior wall from a combination of a lack of a gutter/downspout system for the roof and the existence of clinging ivy on the rear wall. Water damage to the foundation wall (see Picture 4), brick support pillars (see Picture 5) and a basement stairwell (see Picture 6) in contact with the wall itself, indicate signs of chronic water penetration. During the course of the assessment, a thunderstorm producing a heavy rainfall occurred. This rainfall allowed Mr. Feeney to observe water drainage around the exterior of the building. The lack of a gutter/downspout system allows back-splashing rainwater to impact on the ground adjacent to the exterior wall, which results in chronic wetting. This condition allows water to pool against the building's exterior wall and foundation (see Picture 7). Gutters and downspouts should

**Water Damage to Foundation Wall**

be designed to direct rainwater away from the base of the building to prevent the chronic wetting of exterior walls which can result in damaged brickwork and/or mold growth.

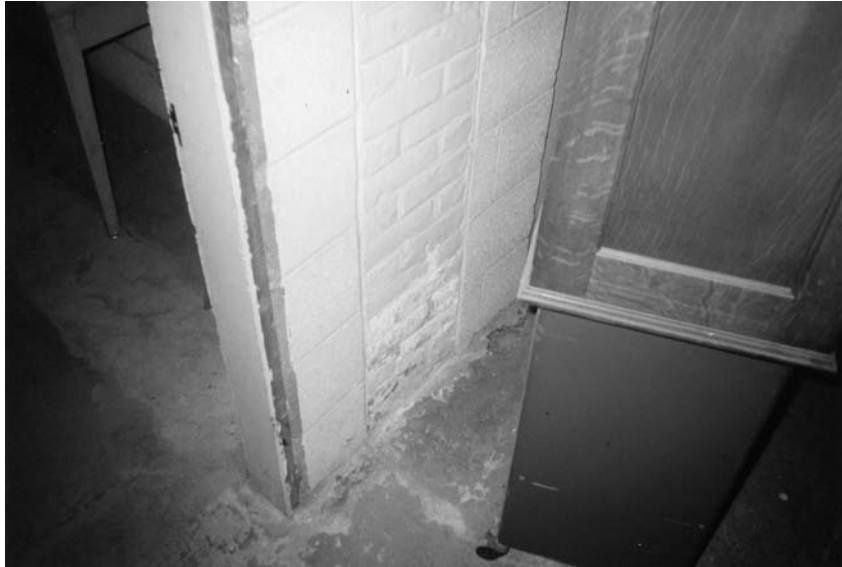
**Picture 5**

**Water Damage to Brick Support Pillars**

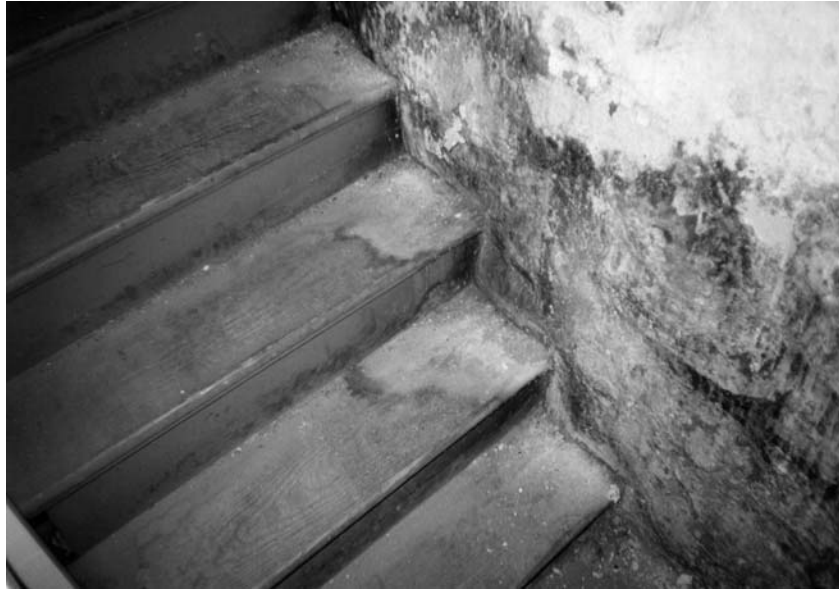
**Picture 6**

**Water Damage to Basement Stairwell and Foundation Wall**

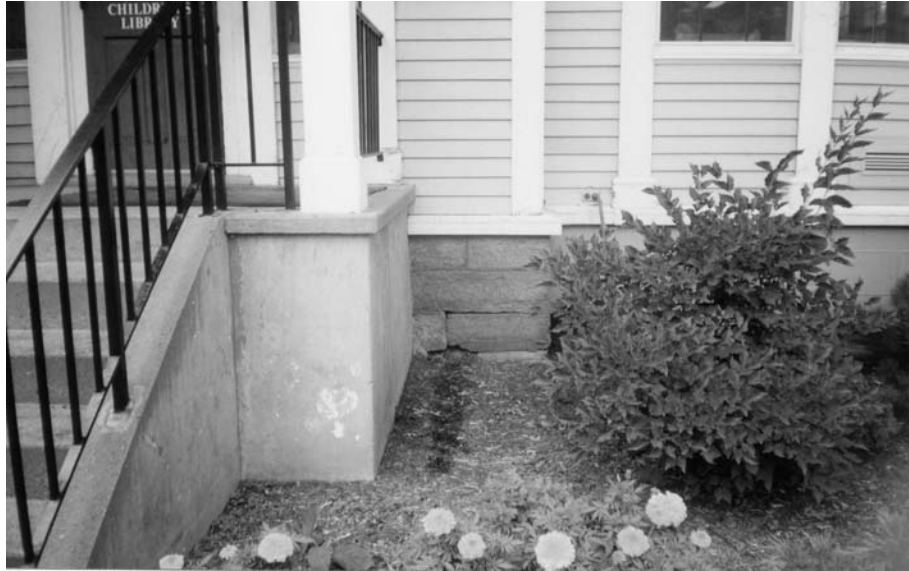
**Picture 7**

**Pooling Rainwater from Roof, Note Damage to Foundation Stone in Proximity to  
Pool**

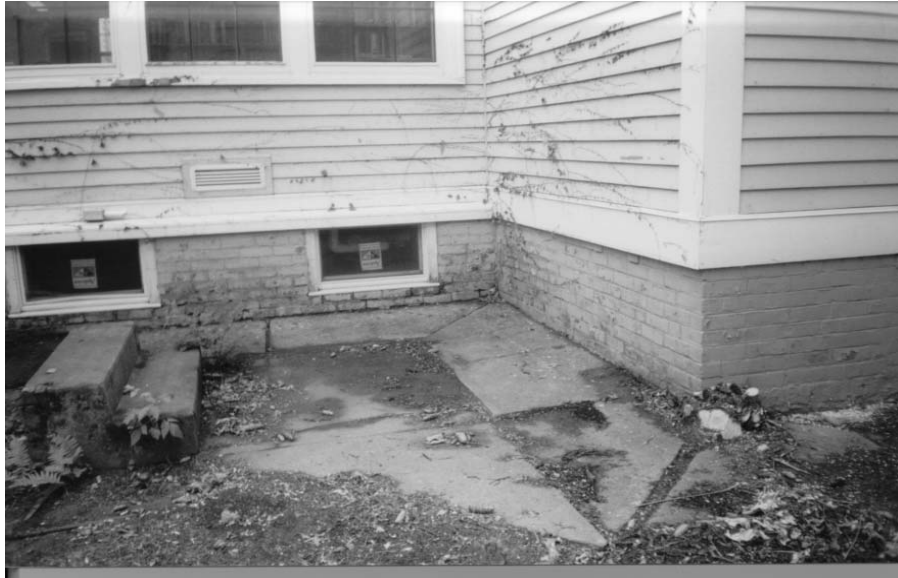
**Picture 8**

Another source of moisture penetration into the building may be through the rear exterior wall, which was formerly covered with a substantial ivy growth (see Picture 8). Clinging plants can cause water damage to brickwork by inserting tendrils into brick and mortar. Water can penetrate into the brick along the tendrils, which can subsequently freeze and thaw during the winter. This freezing/thawing action can weaken bricks and mortar, resulting in damage to the wall. In addition, the growth of roots against the exterior walls can bring moisture in contact with wall brick and eventually lead to cracks and/or fissures in the foundation/slab below ground level. Over time, this process can undermine the integrity of the building envelope and provide a means of water entry into the building via capillary action through foundation concrete and masonry (Lstiburek, J. & Brennan, T.; 2001). In order to avoid this problem, clinging plants on brickwork is not recommended.

**Exterior Wall at Rear of Building Formerly Covered With Substantial Ivy Growth**

11. Continue to remove clinging ivy from the exterior walls of the GPL.
12. For buildings in New England, periods of low relative humidity during the winter are often unavoidable. Therefore, scrupulous cleaning practices should be adopted to minimize common indoor air contaminants whose irritant effects can be enhanced when the relative humidity is low. To control for dusts, a high efficiency particulate arrestance (HEPA) filter equipped vacuum cleaner in conjunction with wet wiping of all surfaces is recommended. Avoid the use of feather dusters. Drinking water during the day can help ease some symptoms associated with a dry environment (throat and sinus irritations).

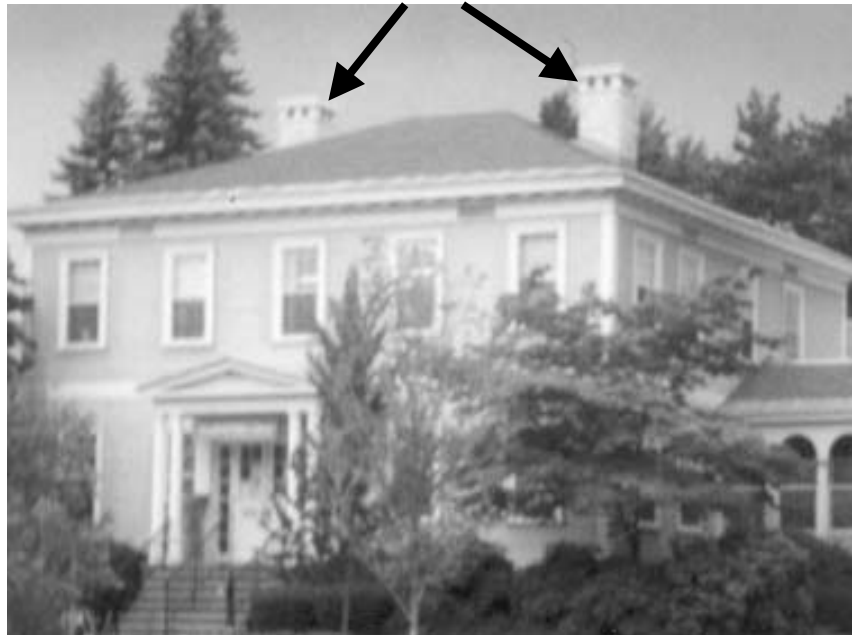
**Picture 9**

**Chimney-Like Structures on the Roof Of the 1797 Wing**

1. Examine the feasibility of providing mechanical exhaust ventilation for the basement book stacks and the second floor offices. For the second floor offices with univents, examine the feasibility of converting the existing airshafts of the original ventilation system into mechanical systems. Contact an HVAC engineering firm to determine if existing vents, ductwork, etc. can be retrofitted for mechanical ventilation.
2. Install a gutter/downspout system to properly drain rainwater away from the foundation
3. Repair roof and replace/repair any water-stained ceiling tiles and wall plaster. Examine the area above and around these areas for mold growth. Disinfect areas of water leaks with an appropriate antimicrobial if necessary.

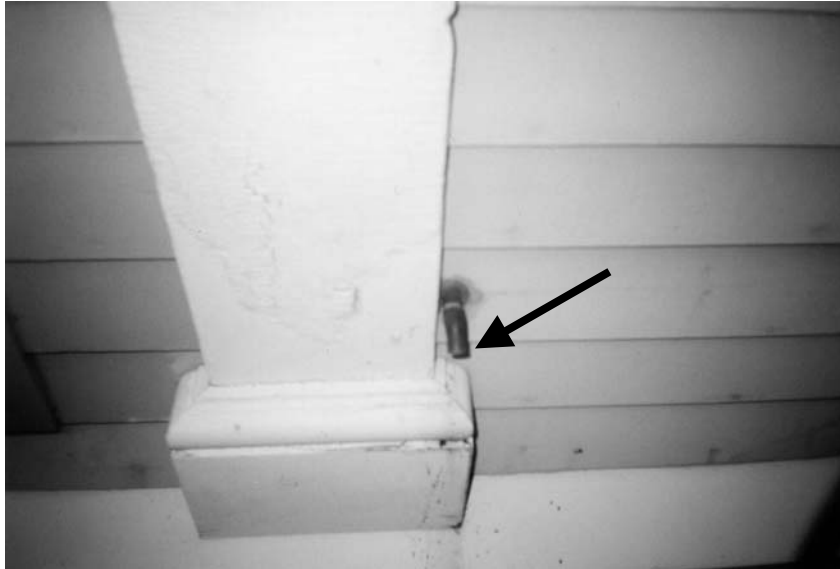
**Picture 10**

Condensation is generated under the following conditions. When warm, moist air passes over a surface that is colder than the air, water condensation can collect on the cold surface. Over time, water droplets can form, which can then drip from a suspended cold surface. For this reason, HVAC systems are equipped with drainage systems beneath cooling coils to drain condensate as moist outdoor air is cooled. Univents have drain (drip) pans that are connected to a drainage pipe system. Each of these drip pans empty through a PVC pipe that exits through the exterior wall clapboard (see Picture 10). Each of these pipes drain condensation directly onto the exterior wall, resulting in chronic moistening that is rotting the clapboard. This chronic moistening can result in water penetration into the interior of the building.

**Condensation Drain Emptying Onto Exterior Wall Clapboard,  
Note Damage to Wood below Drain**

6. Examine other porous materials for mold growth and musty odors. If present, discard these materials.
7. Extend condensation drains to empty at ground level.

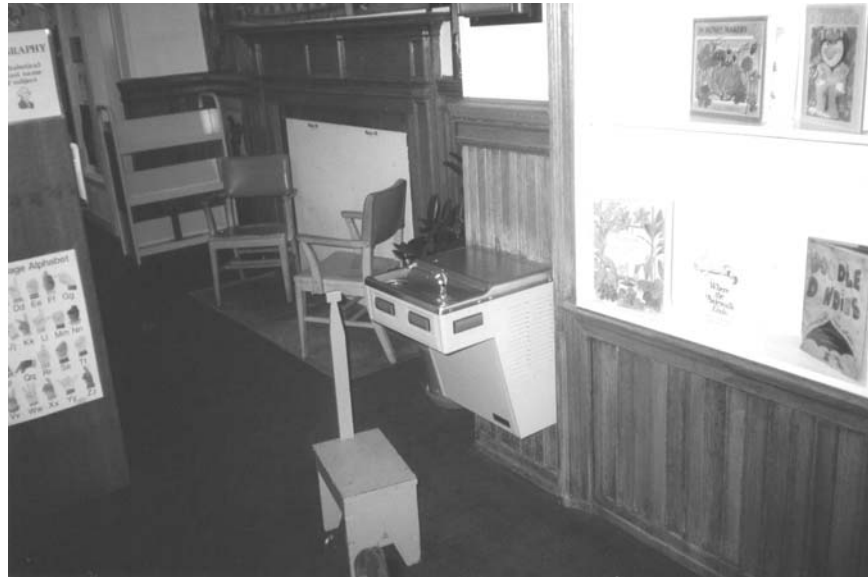
**Picture 11**

A water fountain was observed above carpeting in the children's section (see Picture 11). Spills from the water fountain can result in wetting of the carpet, which can lead to mold growth.

**Water Fountain Observed Above Carpeting in the Children's Section**
